TWR-17548 Volume II

FLIGHT SET 360L009 (STS-36)
CASE AND SEALS COMPONENT FINAL REPORT

NOVEMBER 1990

***Thiokol* CORPORATION**
SPACE OPERATIONS

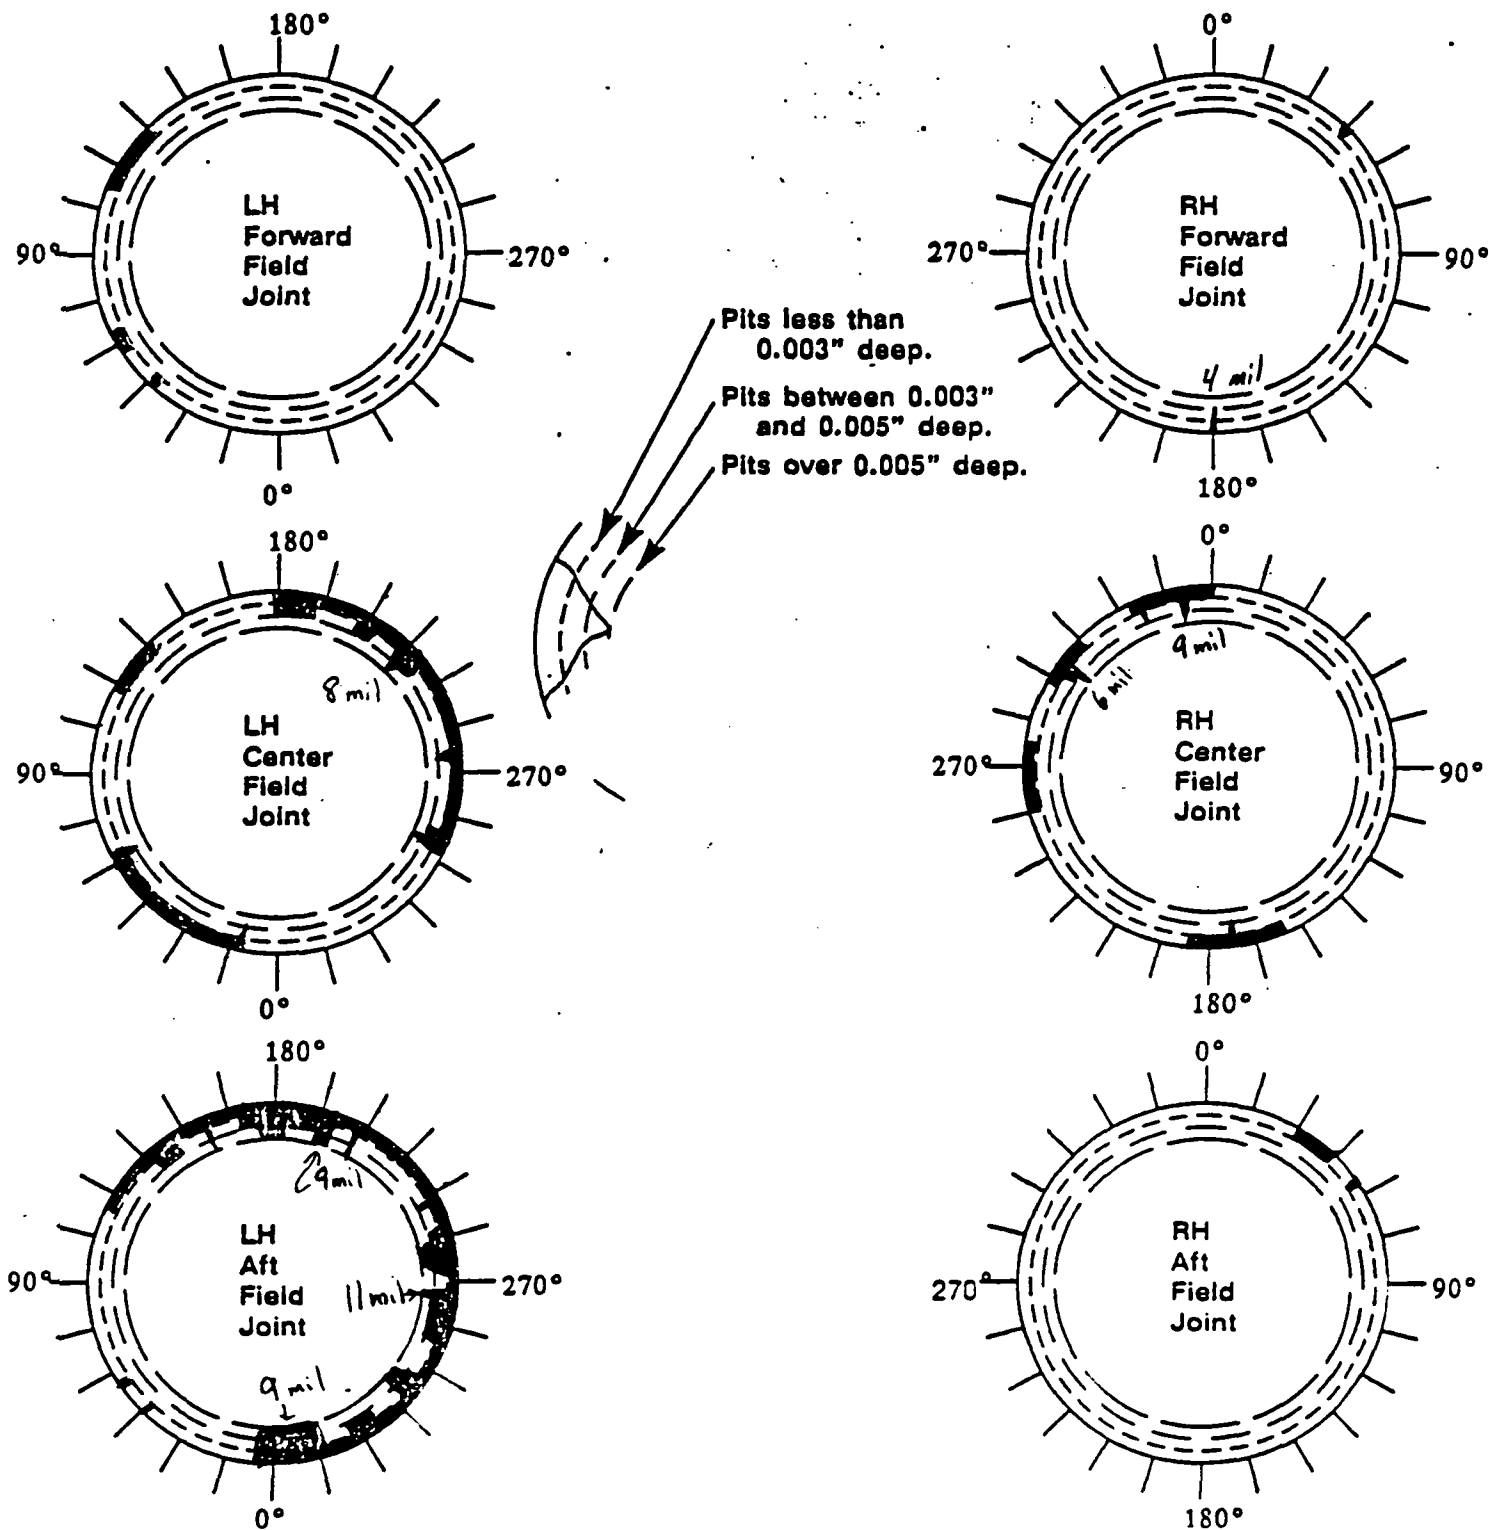
Sketch Overall Field Joint Fretting Observations Below:

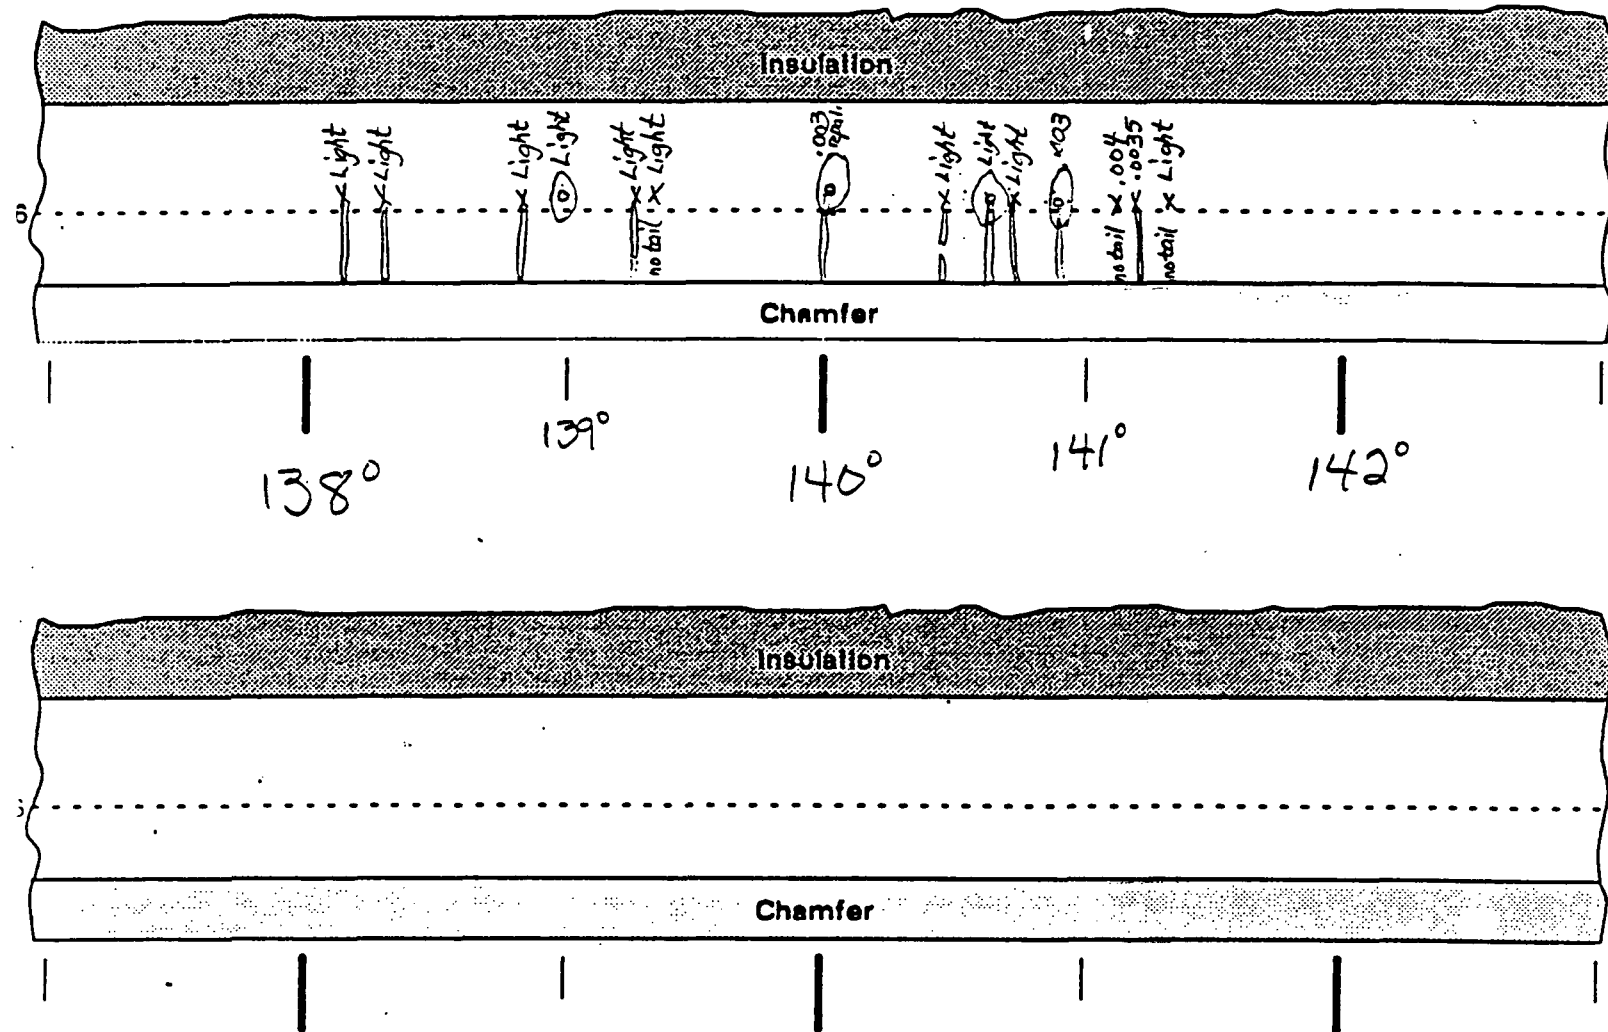
Clarification Number: B-46B

LH/AFT Intermittent light fretting around most of the joint with concentrations of moderate (0.003 to 0.005 inch deep) and heavy (>0.005 inch deep) fretting from 135 through 0 to 9 degrees. Two 0.009 inch deep frets were found at 195, and 350 degrees and a 0.011 inch deep fret at 278 degrees.
